333 Reinitializations (reinit)

Feb 26 2019

333reinit2-5-2019

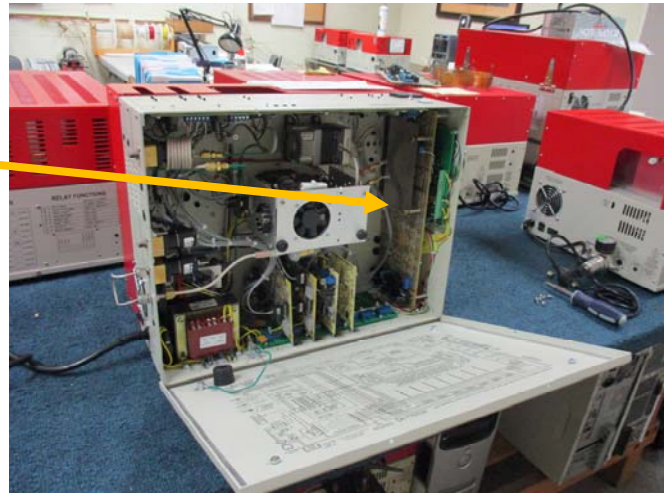
This is the interior of the GC where the 333 is mounted on the far right side..

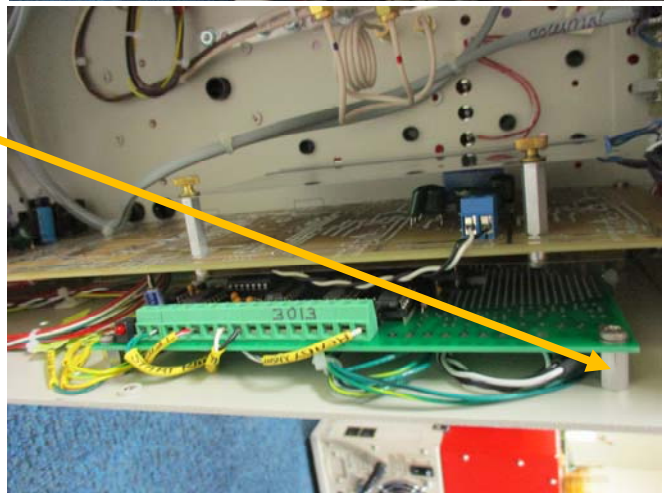
The 333 lives underneath the amplifier board where we have our most sensitive electrometer circuits. Both boards are secured to the chassis with aluminum standoffs

From the outside of the GC, remove the 4 hex head screws which secure the A/D board (through the aluminum standoffs) using a 5/64" hex wrench.

Also remove the 4 hex head screws which secure the amplifier board. This allows the amplifier board to move a little and provide clearance as you remove the A/D board from underneath.

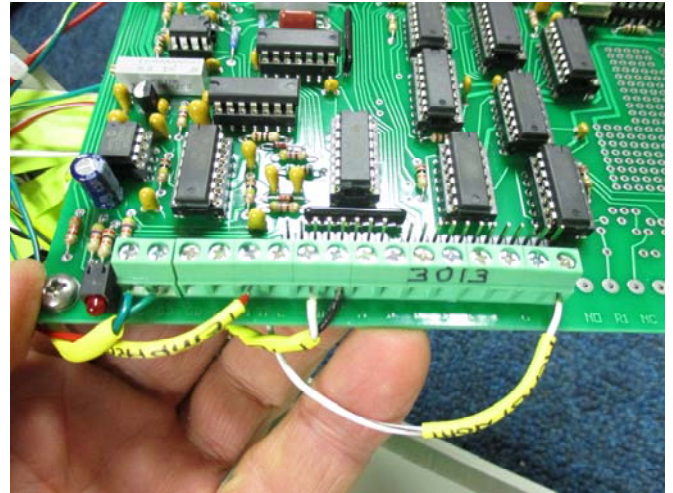
The 333 board looks like this when it has been removed from under the amp board. You don't have to remove any of the wires unless they prevent you from soldering.

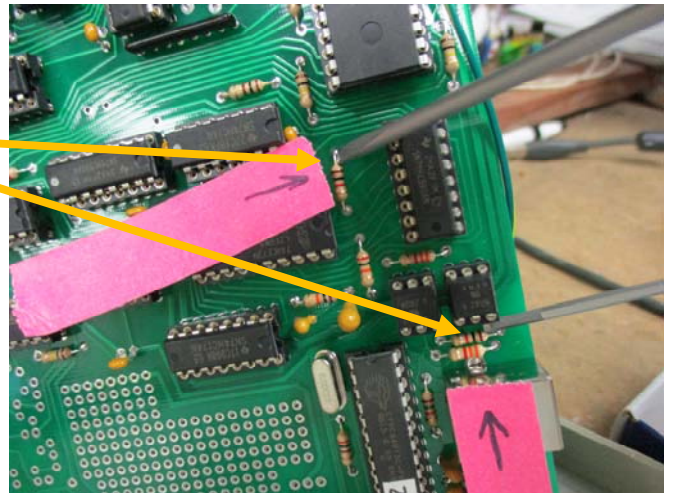
There are two 1000 ohm (1k) resistors which need to be increased to 2000 (2K). You can either replace the entire resistor or lift one leg of the existing resistor and then solder a 2nd 1k resistor to the empty hole in the circuit board.

The resistor has brown, black and red bands to identify it as 1000 ohms.
