If the Valco ( VICI ) Electrically Operated Gas Sampling Valve ( GSV ) in your SRI 8610C Gas Chromatograph does not operate, the problem can sometimes be fixed by replacing the circuit boards inside the valve actuator. This is simpler and less expensive than re-

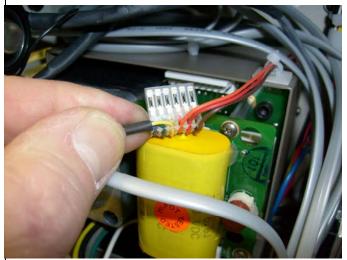
Carefully wiggle out and remove the six pin connector along the top edge of the board. Note that it connects to the leftmost six pins on the board before removing it. Also note the orientation (brown wire on right side).

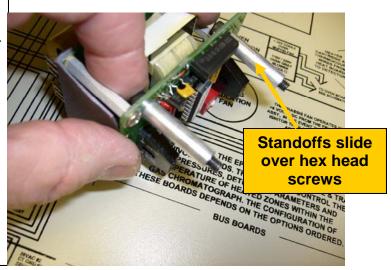
Note how the standoff slides over the hex head nuts. It is easy for the standoffs to slip off when you are installing the new circuit boards.

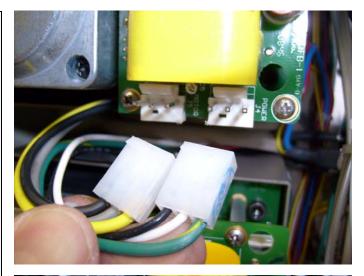
Be especially careful to reconnect the small connector since there is nothing to prevent you from shifting it over onto the wrong small pins. This could damage the boards if reconnected to the wrong place. The blue wire in the connector should line up with the pin farthest to the left.

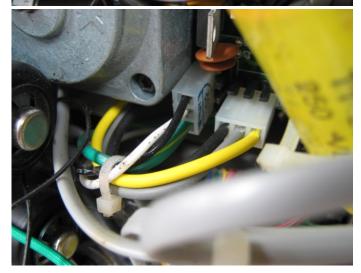
The cable are connected like this. Don't mix them up.
