The "Thermo-couple Out of Range Alarm" (TORA) will illuminate if any of the ACTUAL heater temperatures are less than 5C or more than 425C.

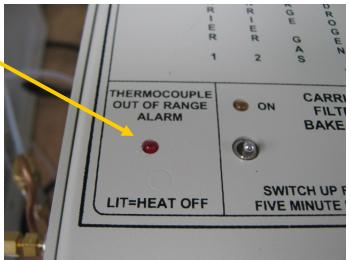
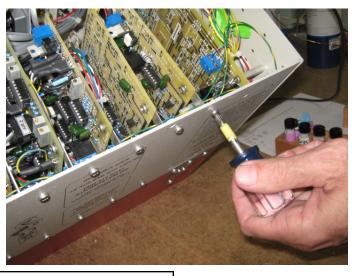
If the TORA appears to be illuminated because one of the heater ACTUAL temperatures is less than 5 or greater than 425, then the problem may be located on the heat control board located inside the GC. There may be several heat boards in the GC depending on the number of heaters installed. Locate the board which controls the heat zone which has triggered the TORA and remove the two screws (phillips#2 screwdriver) on the back of the GC which hold it in place.

There is a third captive screw (long straight blade screwdriver) which secures the board to the underside of the chassis.

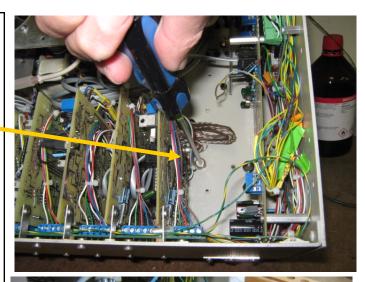
This is the heat board removed from the GC but still connected electrically. If you operate the GC with the board like this, be sure to put something to prevent the board from touching anything. There is mains power on this board so be careful not to touch it when the power is ON.

The heat board is divided into 3 identical heat control circuits.

Some boards may have only one or two of the circuits populated with components.

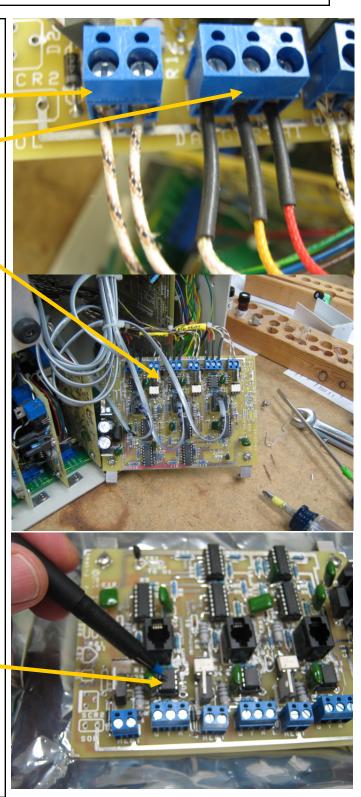
Each heat control circuit has two terminals to connect the heater cartridge.

And 3 terminals to connect the Type K thermo-couple with grounded tip.

There is also a phone cord which connects each heat board to the display board on the front of the GC. The board in the photo has 3 circuits with 3 phone cords.

You can connect the suspected bad thermocouple, heater and phone cord to another one of the heat zone circuits to see if it reads and works correctly on the other circuit.

If it DOES read correctly on another circuit then the thermocouple amplifier chip (INA 114) is the likely problem.

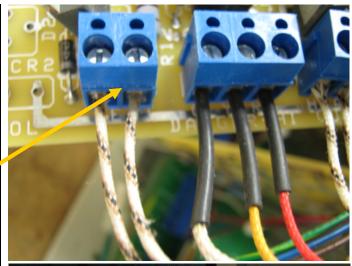
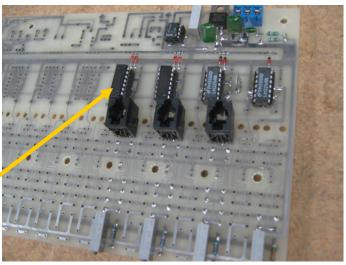
There is a supervisory circuit located on the display board which is connected to the heat board by a grey phone cord. The display board is mounted to the inside of the GC's front panel.

Each heater circuit is connected to one supervisory chip by a phone cored. In some cases, one chip

may supervise two heaters.

Next to each phone cord jack on the display board is the supervisory chip (LM324). When the chip senses the temperature is too high or low it triggers the TORA.

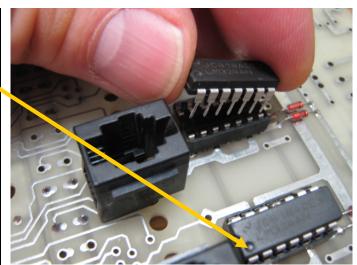
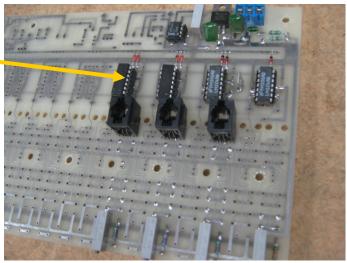
Note the orientation of the dimple on the chip when you remove and replace it.

Sometimes the TORA is triggered because of a failure of the supervisory chip itself. If all the ACTUAL temperatures ARE between 5 and 425C, and no other explanation is likely (Oven Max), then you can experimentally remove the supervisory chips one by one (there may be up to 8 of them on the board).

Turn off GC power, remove one chip, then power on to see if the TORA is still illuminated. If not, then that chip may be bad.

If the TORA is still illuminated, remove the next chip until the bad chip is located.
