333 Reinitializations (reinit)

Feb 26 2019

333reinit2-5-2019

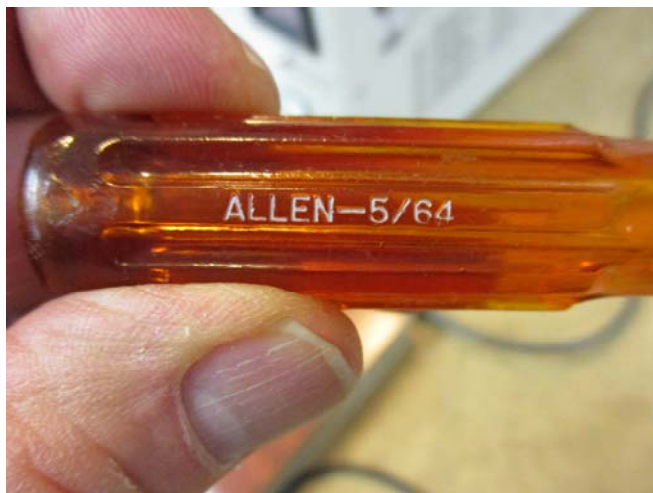
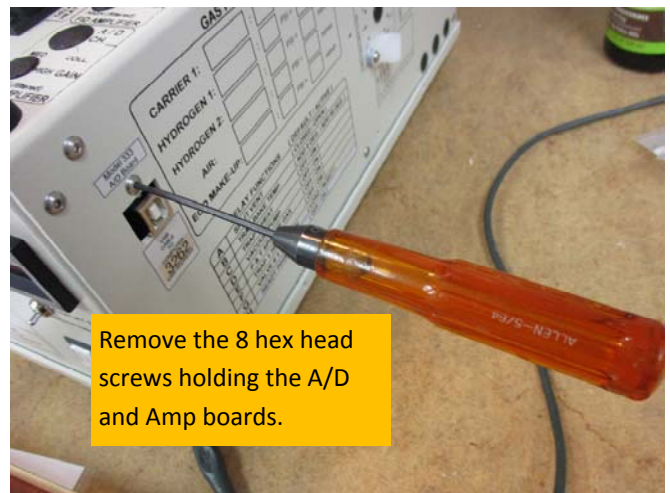
From the outside of the GC, remove the 4 hex head screws which secure the A/D board (through the aluminum standoffs) using a 5/64" hex wrench.

Also remove the 4 hex head screws which secure the amplifier board. This allows the amplifier board to move a little and provide clearance as you remove the A/D board from underneath.

There can be many wires hanging and you might have to disconnect some of the wires from the A/D board to get to the board to wiggle free.
